THE CARDON MANAGEMENT GROUP

August 5, 2004

SUBJECT: Boom Hoist - Motor Vessel Leon I

July 1, 2004

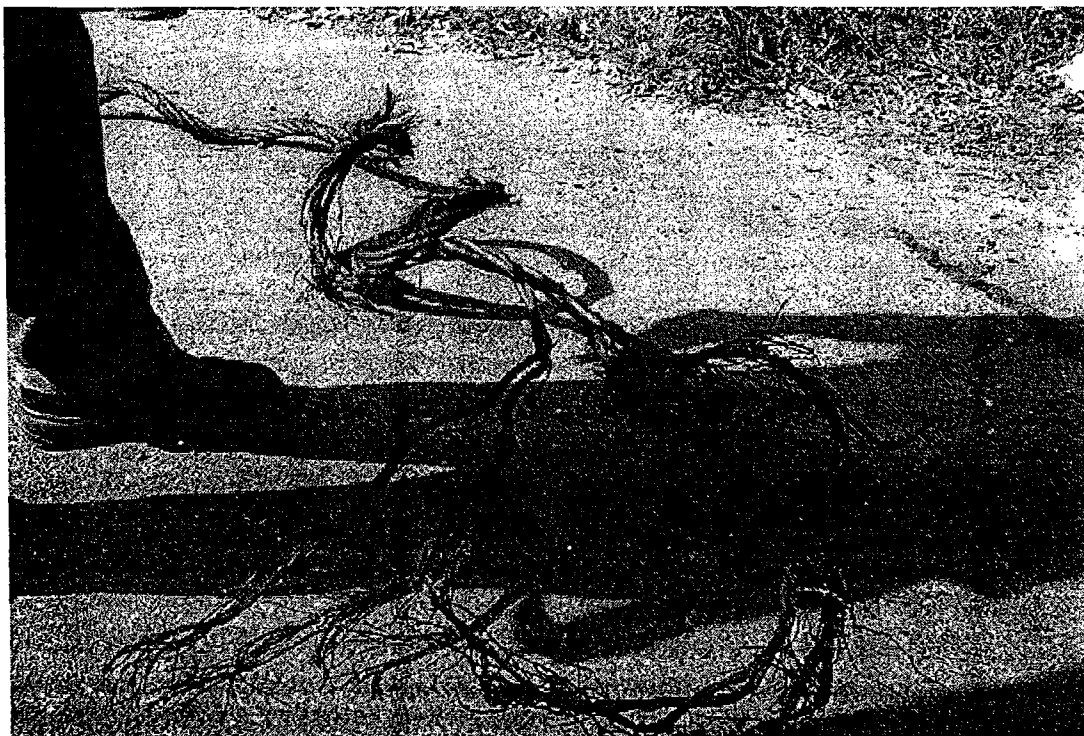
**Photograph Marked DSC00285**

This photograph illustrates the post-accident condition of one end of the broken wire rope at the point of failure, displaying the severe corkscrew-like distortion of the wire rope. The appearance of this kind of extreme mechanical damage is ample demonstration that the wire rope was trapped and forced to bend while under tension over a very small radius at this point.

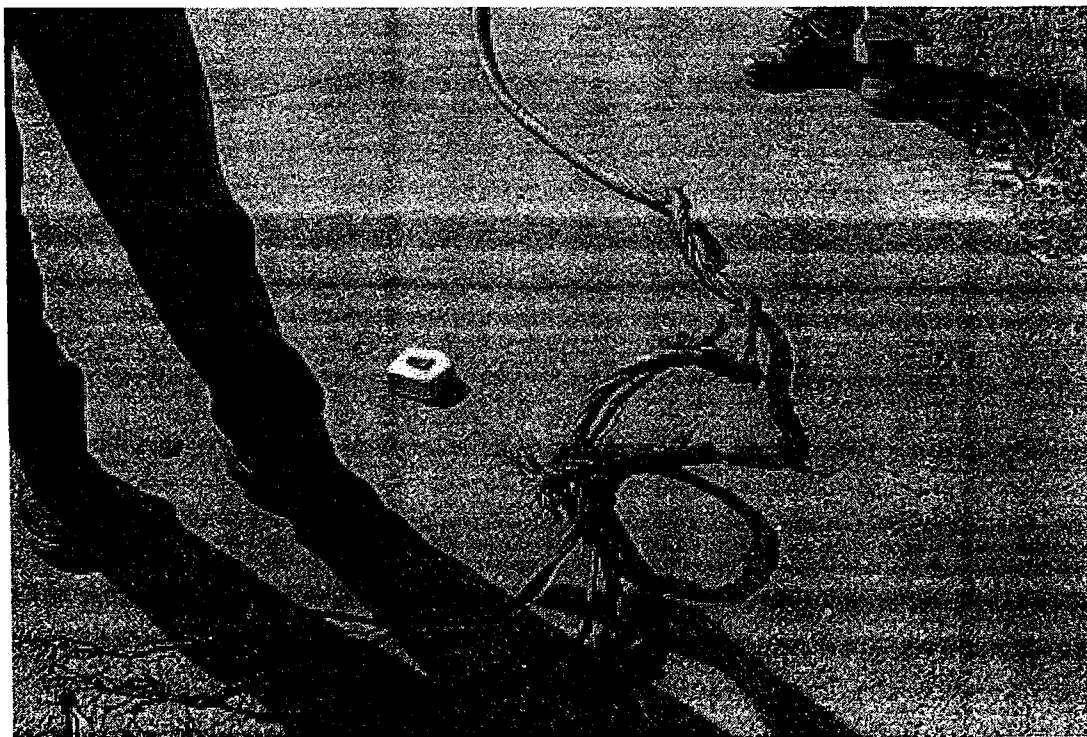
**Photograph Marked DSC00289**

This photograph illustrates the post-accident condition of the other end of the broken wire rope at the point of failure illustrating that one strand failed first under tension in the region of severe mechanical distortion leading to sequential and immediate failure of the other strands at points where there is no similar distortion illustrative of small radius bending.

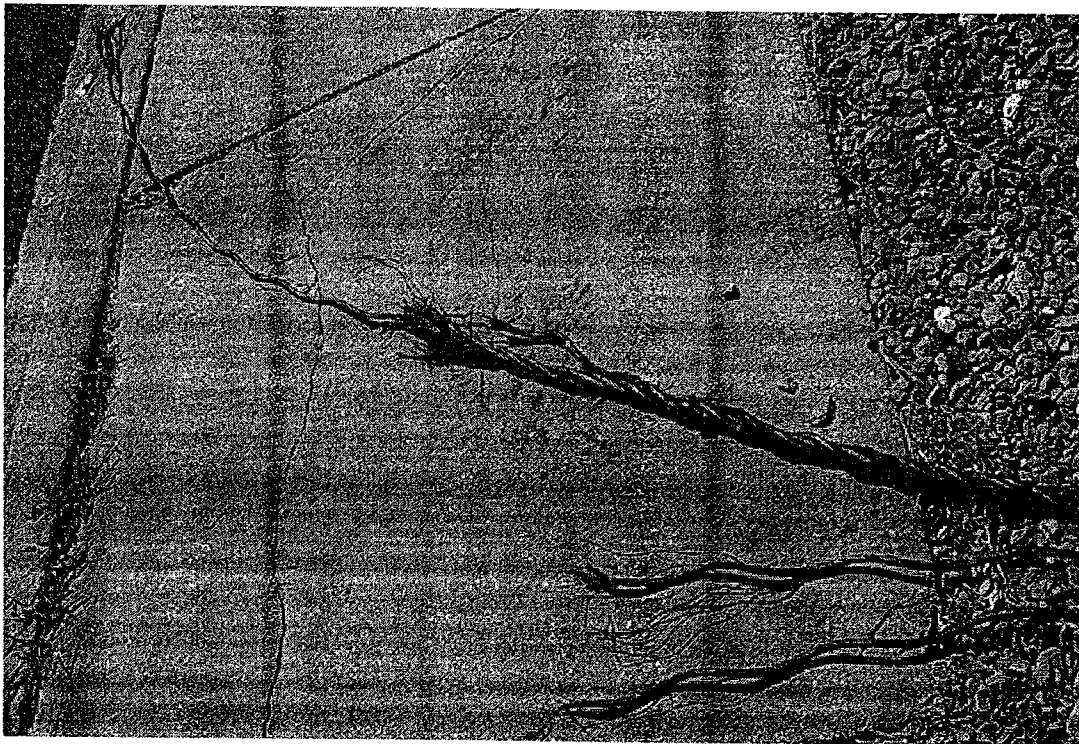
**Photograph Marked DSC00286**

This photograph of the wire rope in post-accident condition at the point of failure shows the location, evidenced by the taped cut ends, which appears to be the place where a sample length was removed during an earlier investigation. It is obvious there is no severe mechanical deformation caused by small radius bending in the region immediately adjacent to the point of failure.
